PRECISION IN-SITU MACHINING

REPAIR TO CAMSHAFT POCKET ON PIELSTICK ENGINE ON CAR FERRY

The Pride of Bilbao, a car ferry traversing the route between England and Spain, required a repair to its Pielstick engine.

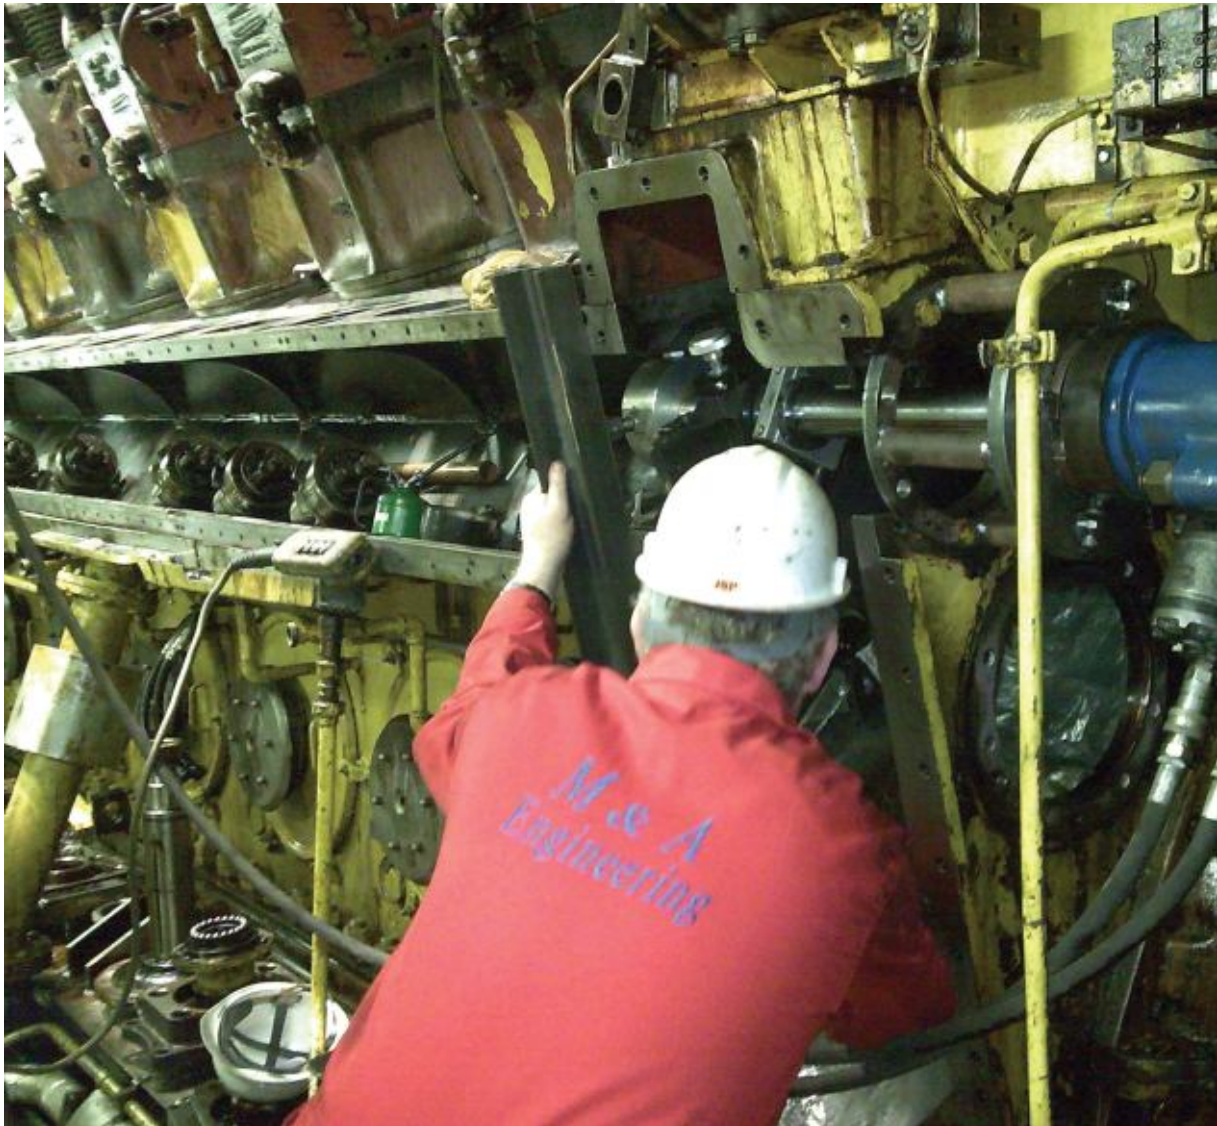
The Pielstick 12PC2.6 2V400 main engine camshaft pocket face had become fretted, resulting in a deviation in the camshaft straightness.

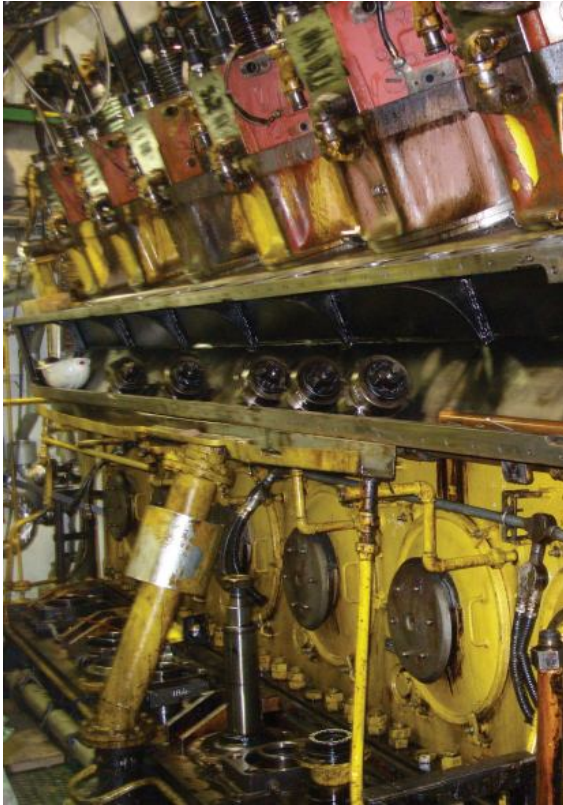
**Checking The Deviation In The Face
, In Relation To The Housing Bores**

M&A Engineering checked the deviation in the face in relation to the housing bores and machined the faces to achieve the desired result

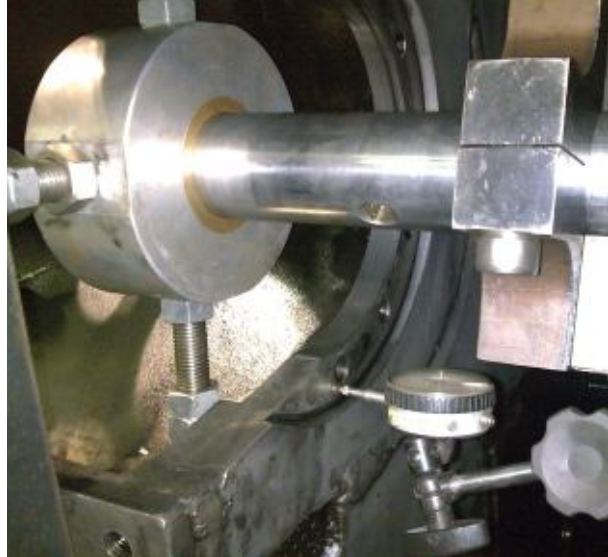
Machining In Progress
