PRECISION IN-SITU MACHINING

REPAIRS TO BOW THRUSTER DRIVE SHAFT BEARING HOUSING - BORING TO ACCEPT SHRUNKEN SLEEVE AND SUBSEQUENT SLEEVE BORING

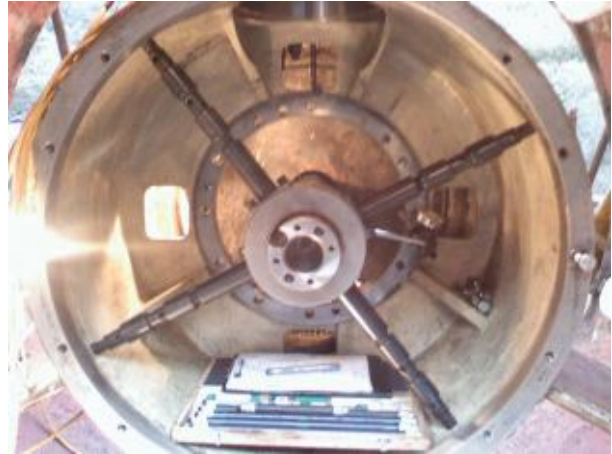
The Stena Europe was found to have excessive wear in the lower housing bore for the bow thruster drive shaft during a dry dock inspection. The best solution would be to bore out the existing housing to accept a sleeve which, in turn, would have to be machined out to return the housing to its original dimensions - exactly.

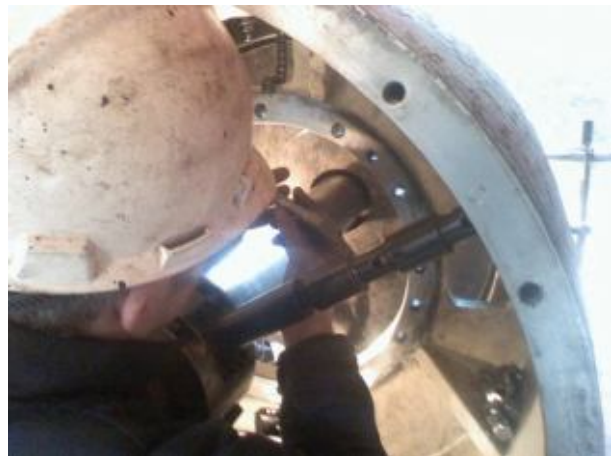
The ships engineers also wished to check the angularity between the Drive Shaft and Bow Thruster Shaft, where the pinion gears mesh.

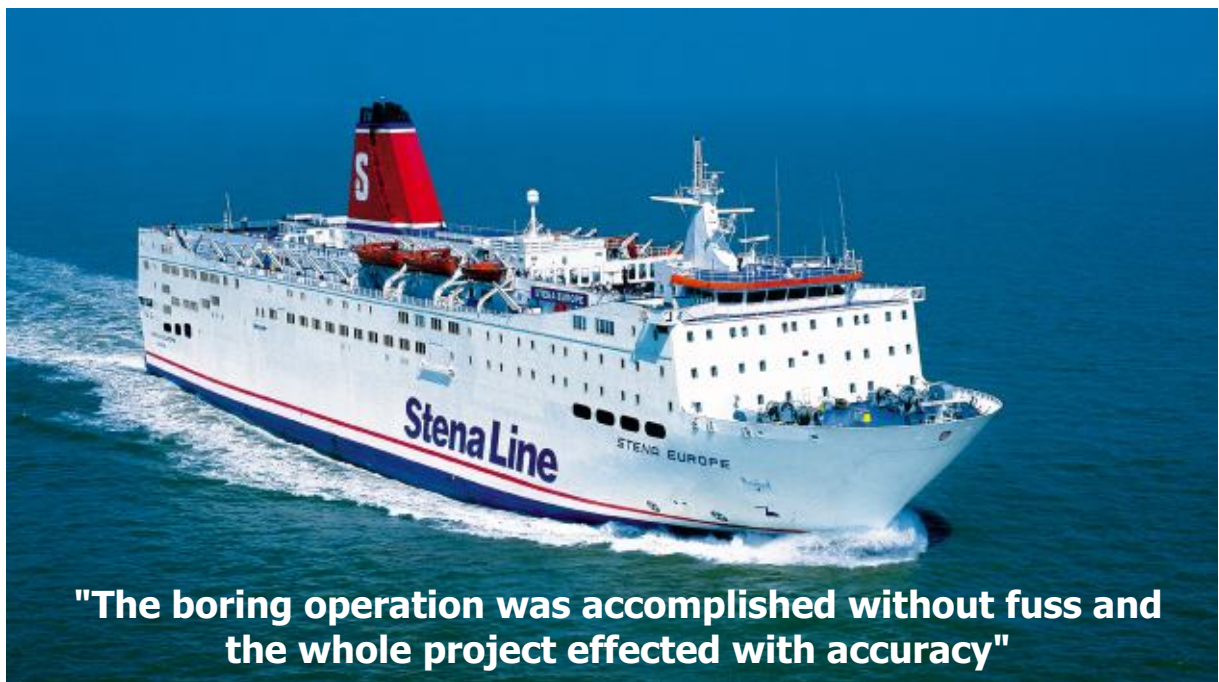
M & A utilised one of its range of heavy duty line boring bars to replicate the position of the Bow Thruster Shaft. When the vertical bar had been set in the drive shaft housing bores, a sweep reading was taken across the horizontal bar. No error was found.

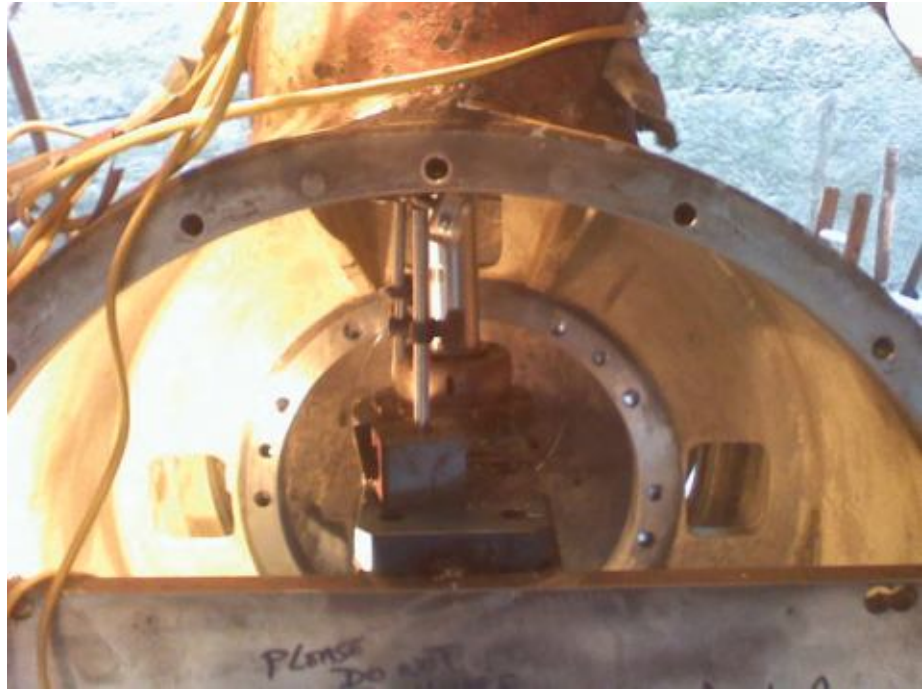
**Lower Bearing
And Support**

To allow the sleeve to be fitted, the adjacent webs also had to be machined away. This required additional bracket supports mounted in the Bow Thruster housing to locate and centralise the lower machine bearing.
