PRECISION IN-SITU MACHINING

LINE BORING AND CORRECT ALIGNMENT OF CUTLASS BEARING ON RACING YACHT S Y ADIX

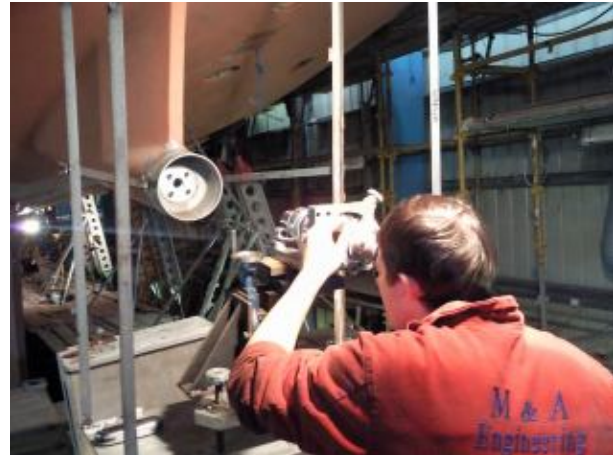
Optical alignment of the shaft path prior to line boring and installation of new cutlass bearings

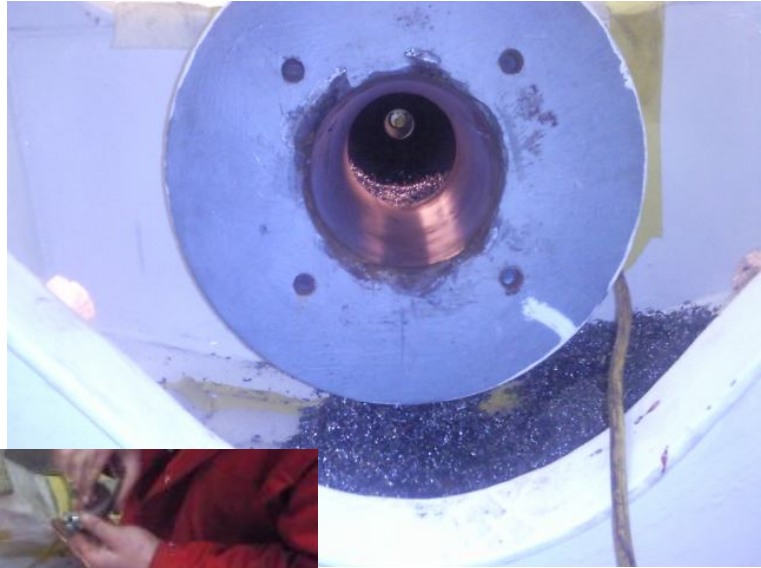
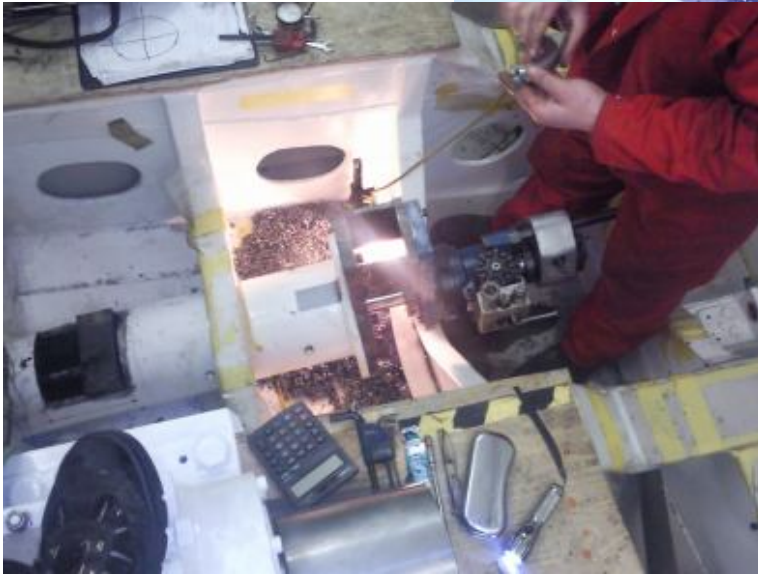
Machining in progress
